MISCELLANEOUS PAPER SL-83-6

INVESTIGATION OF CEMENT PASTES AND RELATED MATERIALS BY SCANNING ELECTRON MICROSCOPY AND X-RAY DIFFRACTION

Katharine Mather, Charles R. Hallford,
J. Pete Burkes, and Alan D. Buck

Structures Laboratory
U. S. Army Engineer Waterways Experiment Station
P. O. Box 631, Vicksburg, Miss. 39180

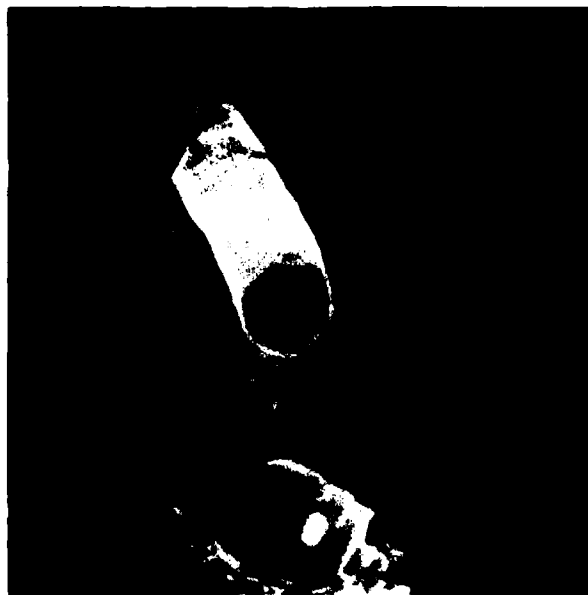
Figure 11. Ettringite-forming material, hydrated at 0.5 W/C. Specimen aged 3 days. This is the center part of Figure 10. In the center of this figure is a rod of ettringite with a hexagonal cross section. This rod, 1 μ m in length, developed normal to the grain surface, while the majority of the smaller rods developed parallel to the grain surface and were typically 0.4 μ m in length (20,000X)

13. At 1 day, there was little recognizable in the way of crystal shape in the ettringite-forming material (Figures 8 and 9). Many large irregular grains were coated or partially coated with short rods of ettringite that were usually parallel to the substrate. The only major changes detected in the 3-day-old specimen was the presence of a few larger ettringite prisms (Figures 10 and 11). At 7 days, gypsum had developed and ettringite had increased. The texture of the sample was less porous (Figure 13). Some of the platy gypsum grains exhibited well developed crystal outlines (Figure 14).
